**APPENDIX E:**

**PHOTOGRAPHS**

*This SUB-APPENDIX provides a copy of ACTUAL PHOTOGRAPHS taken during the Asbestos Building Audit Survey.*

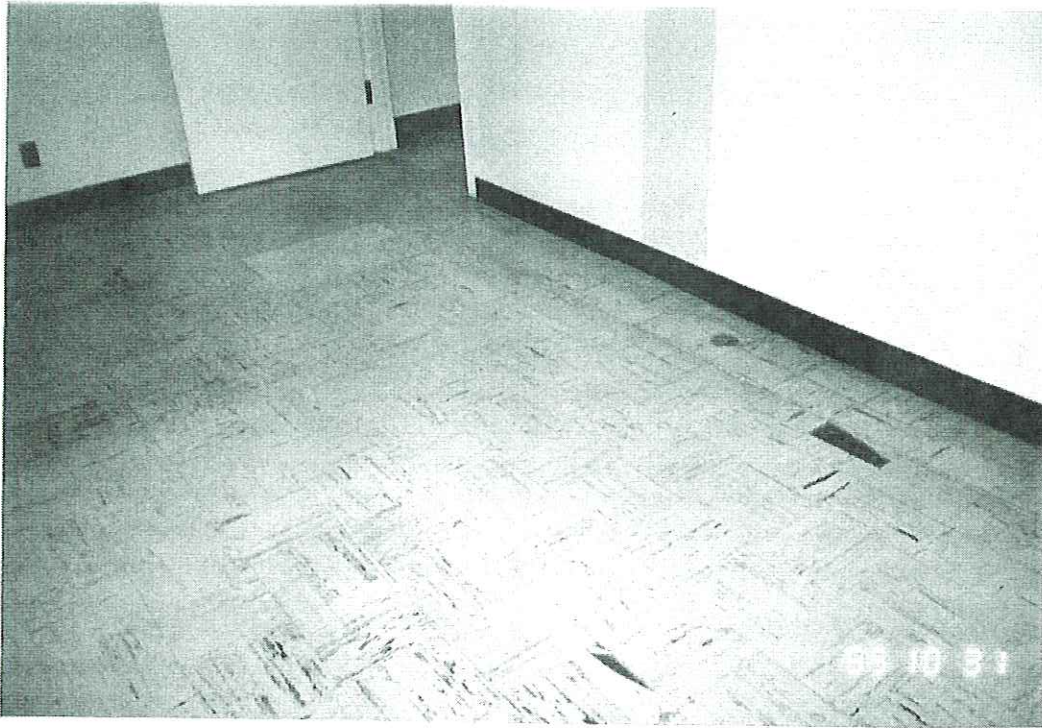
*Photo 3: 9" X 9" floor tile exists throughout most of the building and is usually covered by carpet.*

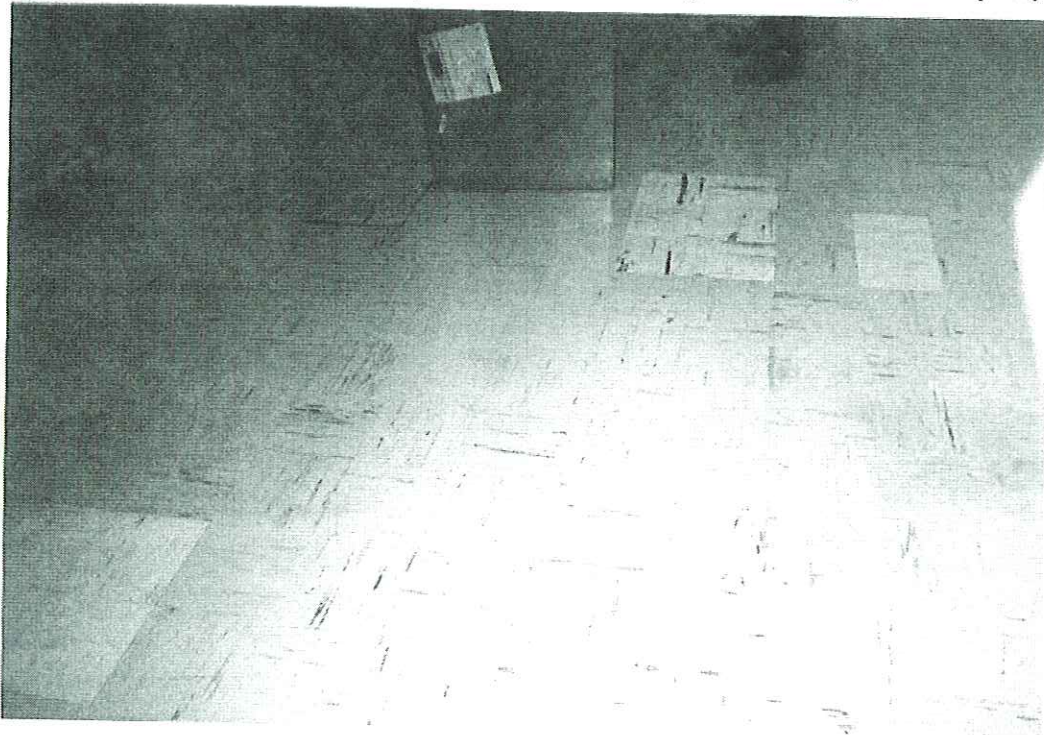
*Photo 4: 9" X 9" floor tile exists throughout most of the building and is usually covered by carpet.*

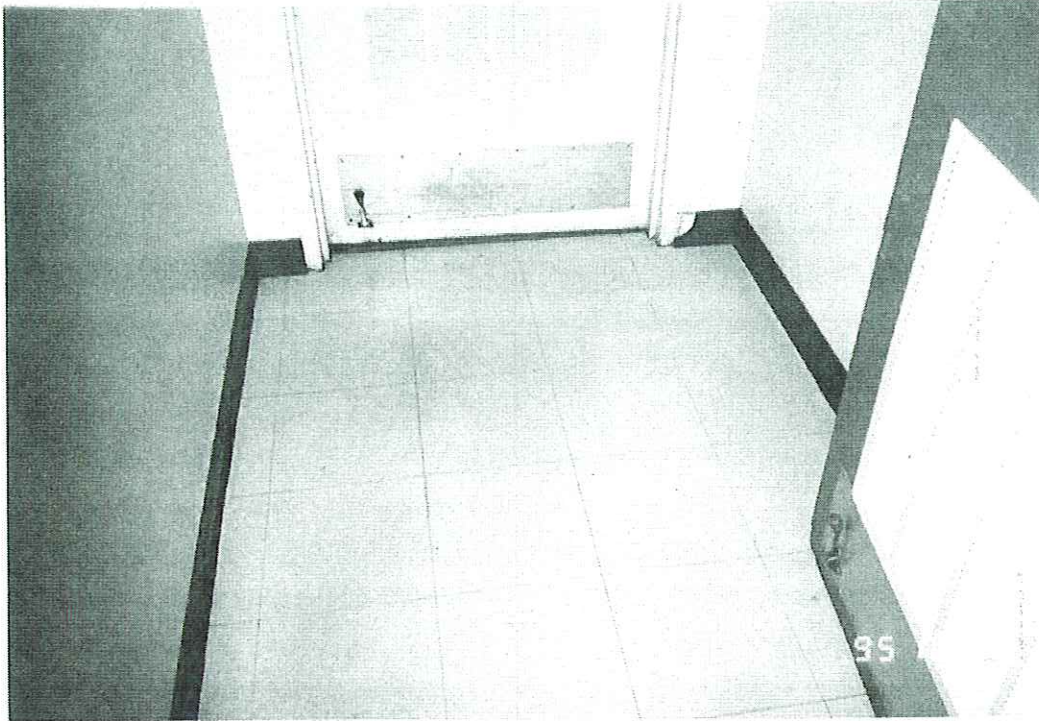
*Photo 5: Mastic beneath beige floor tile in Restroom vestibules contains asbestos.*

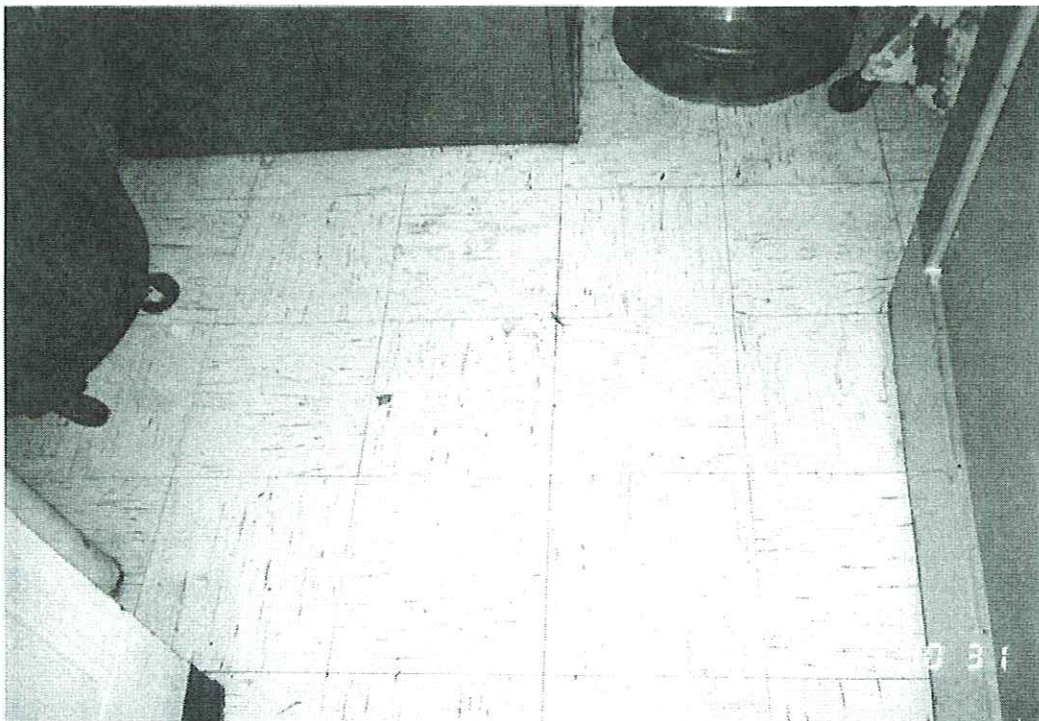
*Photo 6: Asbestos-containing floor tile and mastic was identified in each janitor closet.*

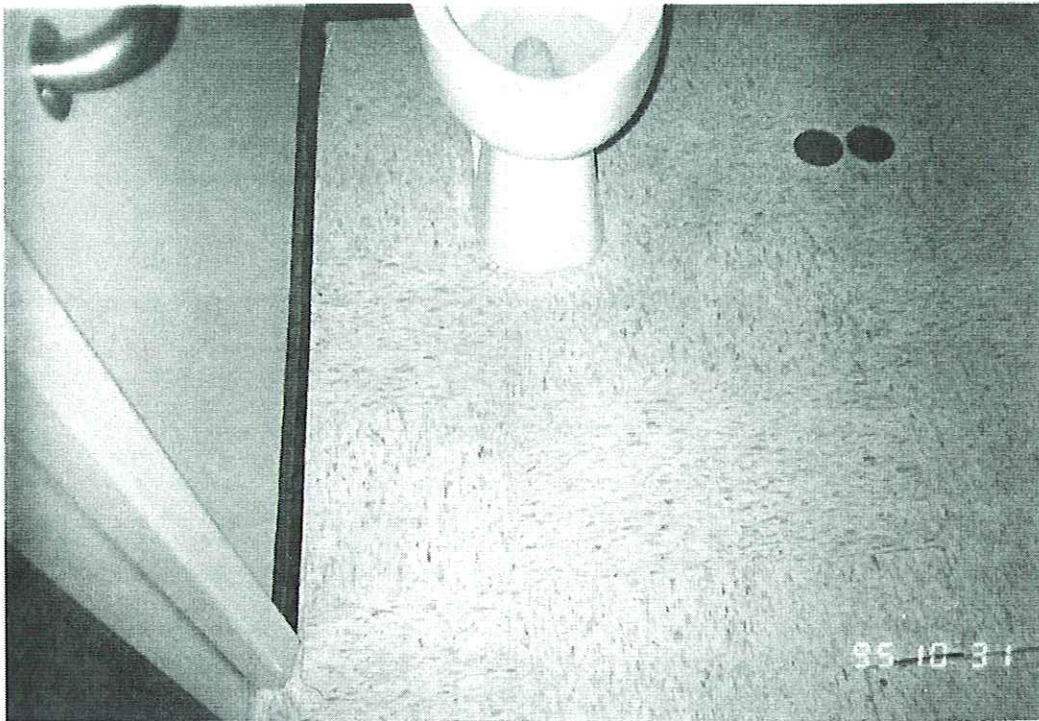
*Photo 7: Mastic beneath 1'x1' floor tile in Rooms 1307G & 1307H contains asbestos.*

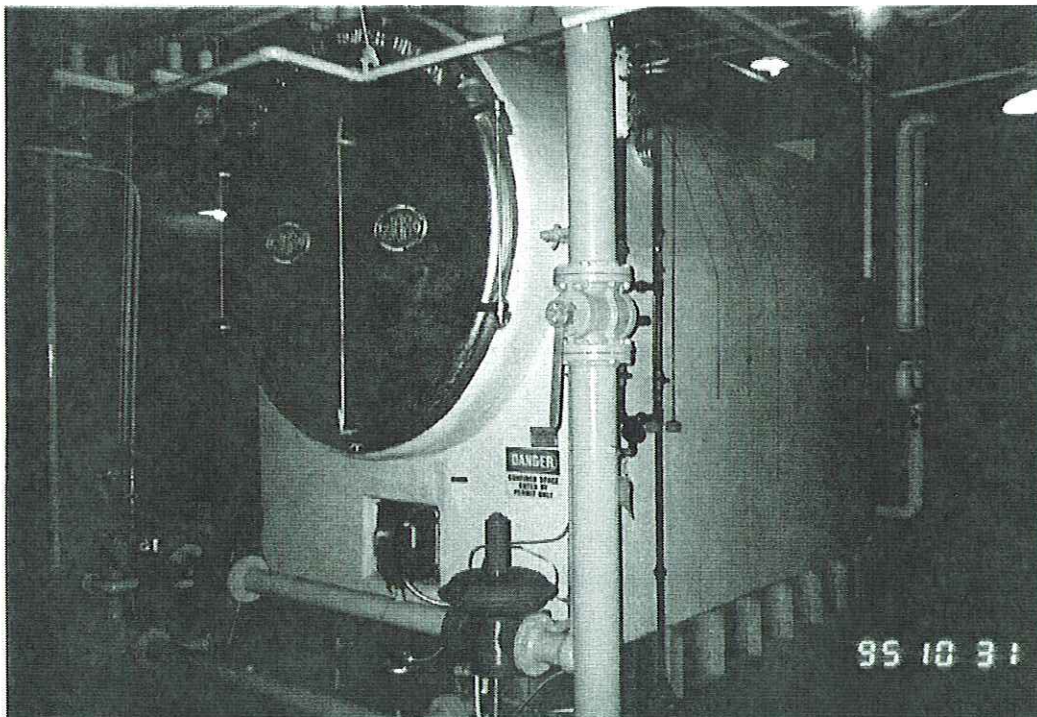
*Photo 8: Insulation on Boiler #4 in Room S24 contains asbestos.*

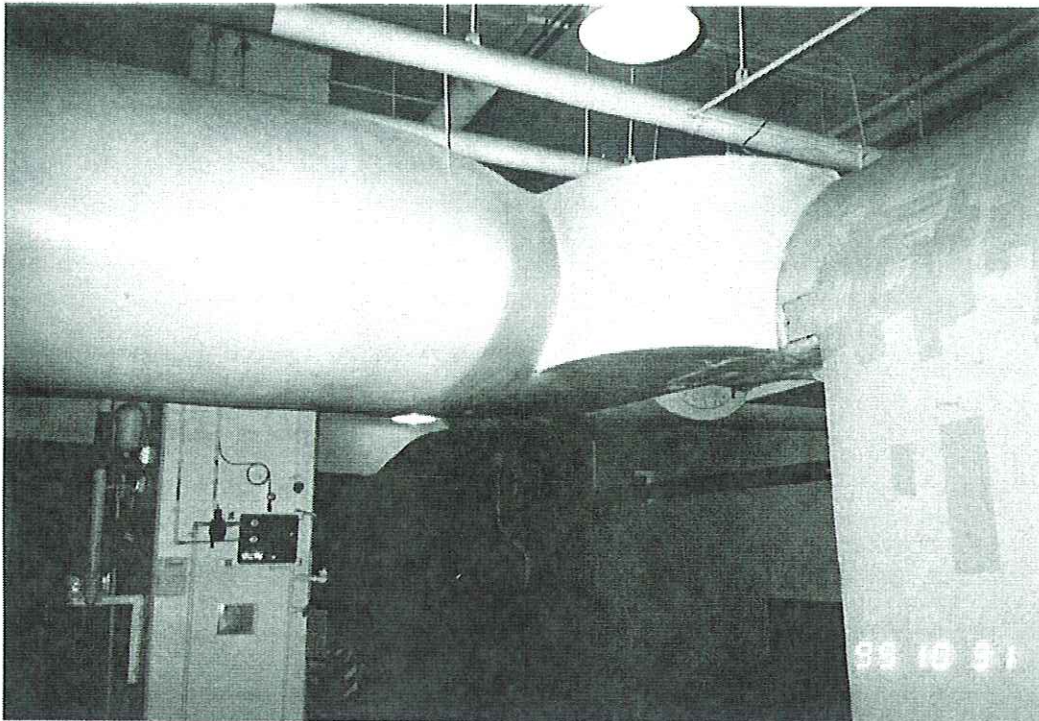
*Photo 9: Insulation on both round and square boiler flues (breaching) contains asbestos.*

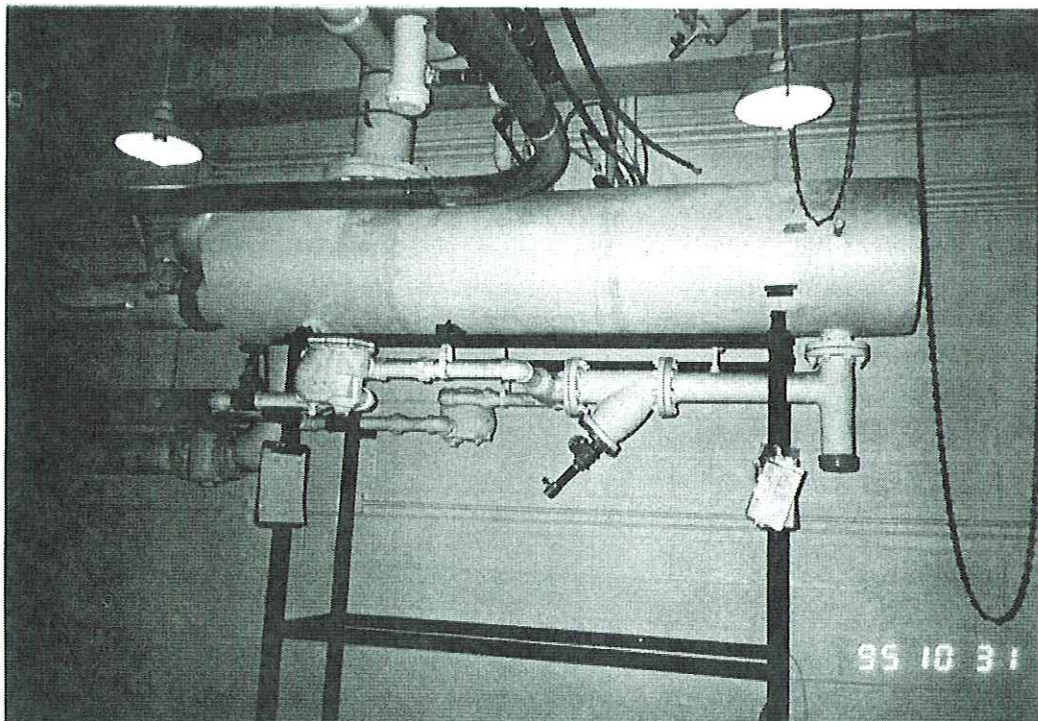
*Photo 10: Expansion Tank Insulation in Boiler Room contains asbestos.*

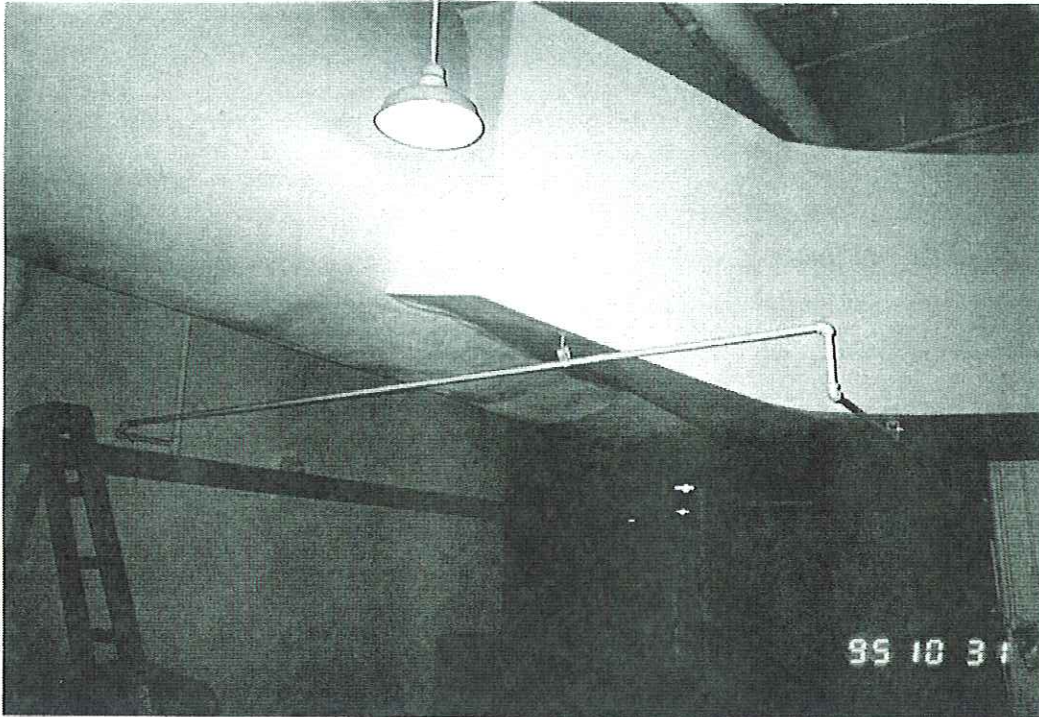
**Photo 11:** *Insulation on both round and square boiler flues (breaching) contains asbestos.*

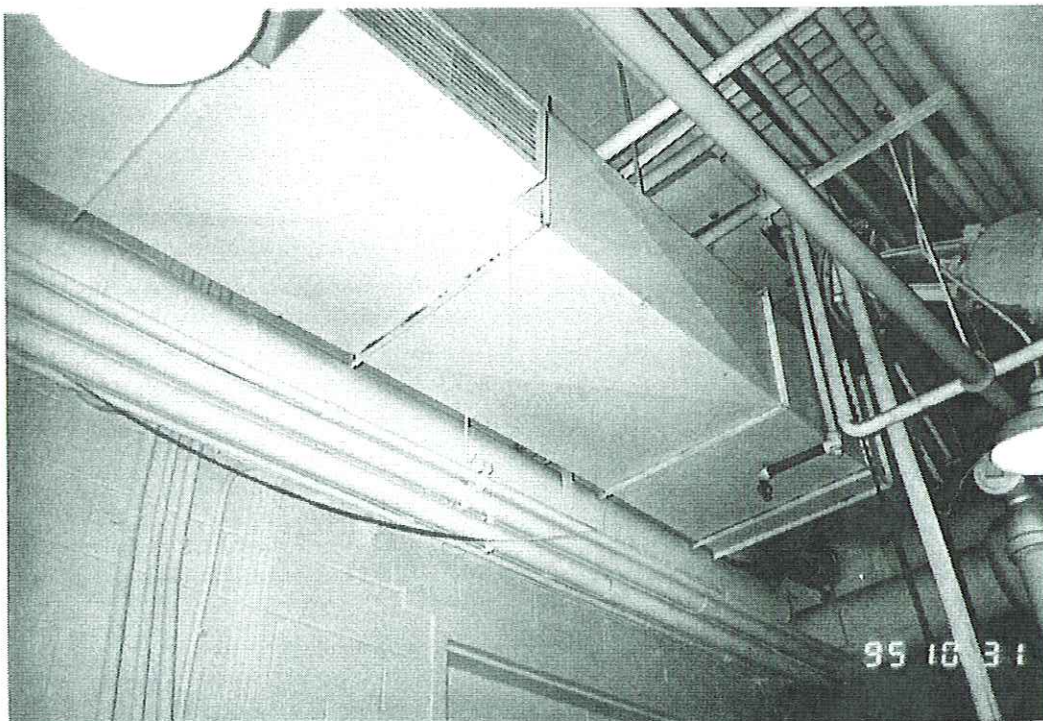
**Photo 12:** *Exterior of Air Handler Duct is not insulated.*

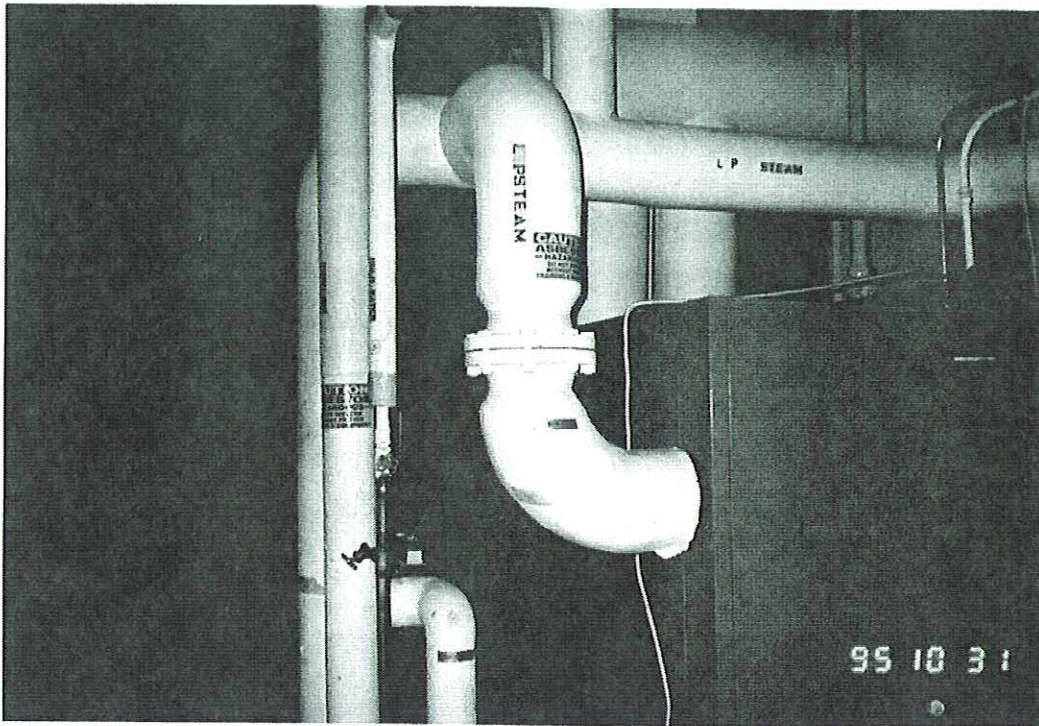
*Photo 13: Steam Lines Fitting Insulation in Room S24 contain asbestos.*

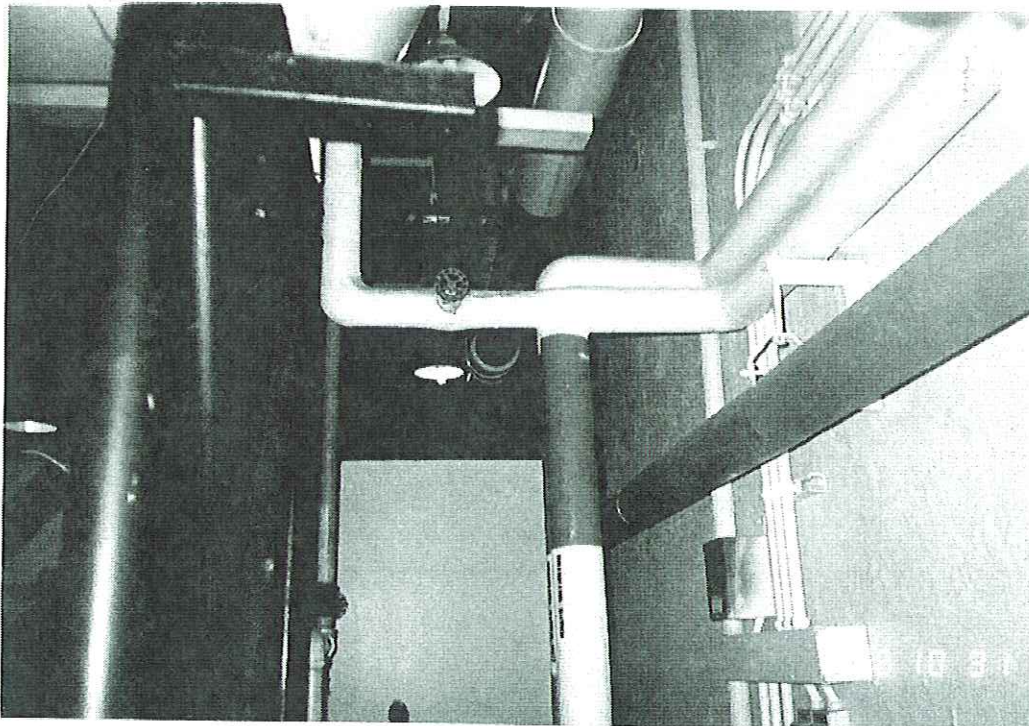
*Photo 14: Drinking Water Supply Lines Fitting Insulation in Room S24 contains asbestos.*

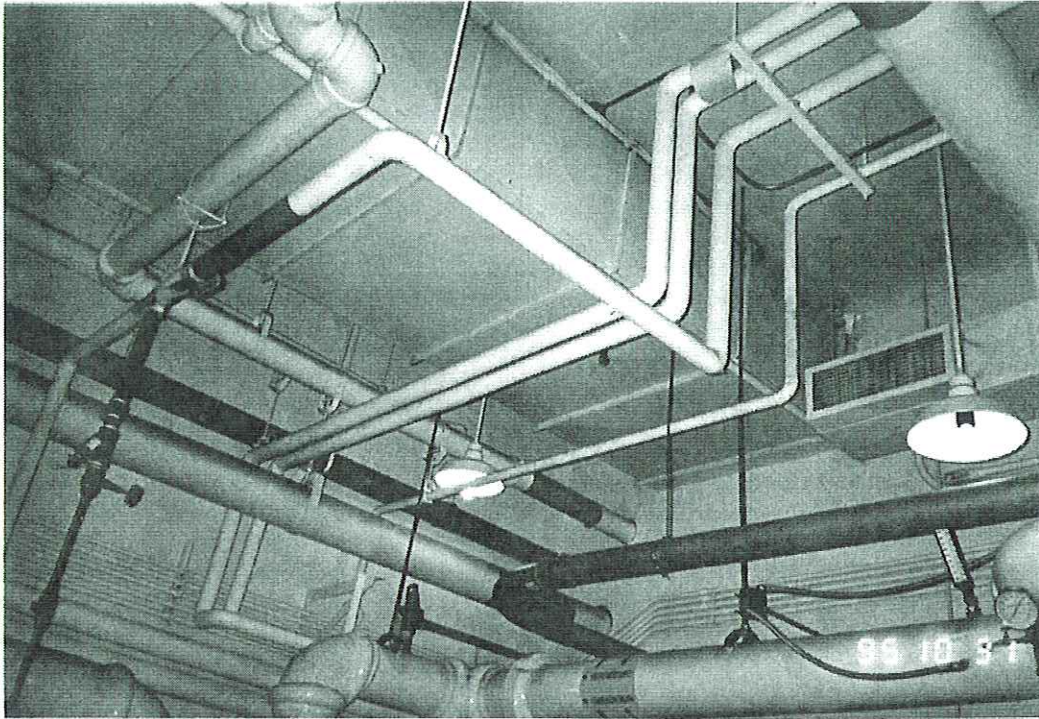
*Photo 15: Boiler and Chiller Cold Water Lines Fitting Insulation in Room S24 contains asbestos.*

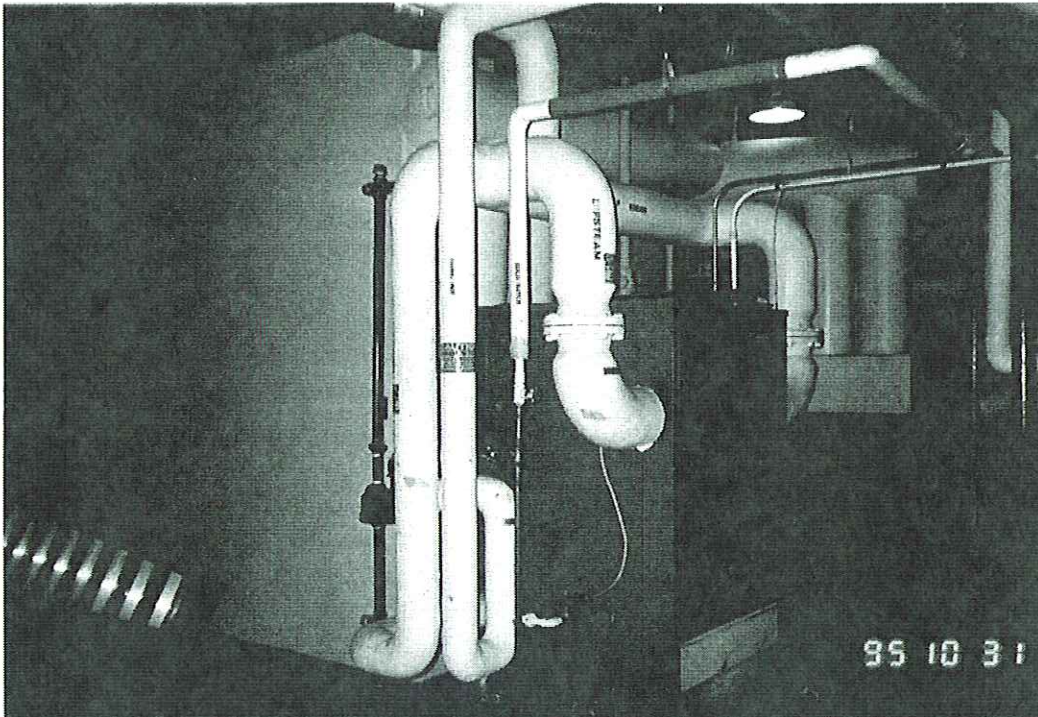
*Photo 16: Typical steam system fittings located in boiler room contain asbestos.*
